Toxigenic Cyanobacteria and Rapid Response Plans

Dr. Doug Pullman

Senior Aquatic Scientist

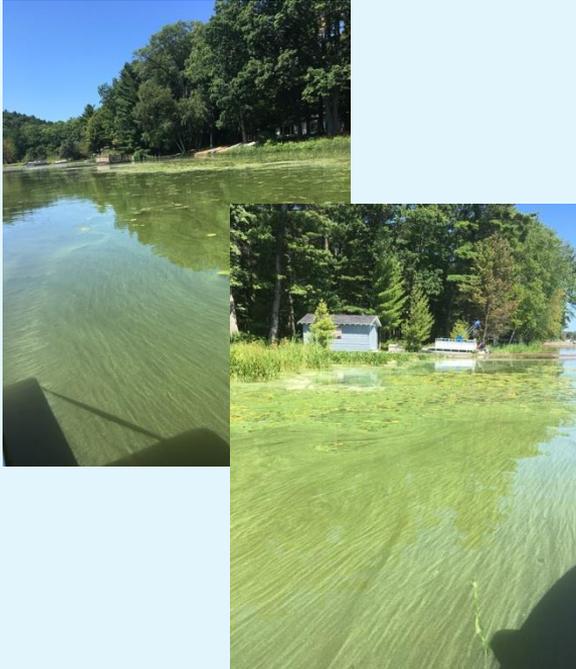
MONITORING TRIGGER POINTS

- Observation** Residents (sentinels) observed blooms that are obvious for more than 5 days? Weeks?
- Detection** ELSIA reveals toxin higher than guidance levels when “obvious” worsen
- Notification** Lake Management Authorities and Changing Conditions
- Mitigation & Verification** Assessment of treatment outcomes

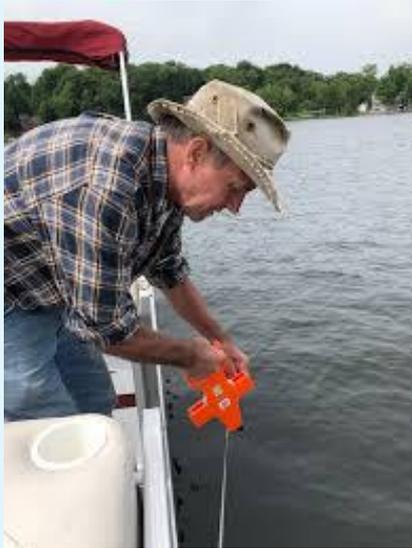
Observation

Citizen Volunteers

Photos were taken in July, but blooms intensified 19 August 2019.

Observations were recorded for predetermined observation sites (AROS) for efficient communication.

Consultant notified - collected samples and smart phone photos 19 August 2019. Consultant notifies State

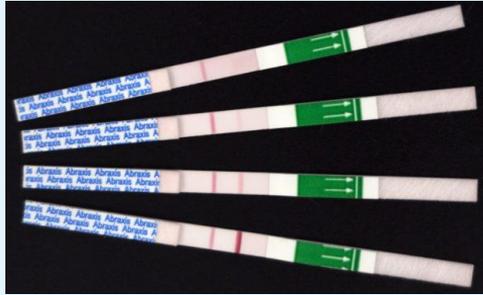
Abraxis "Sticks"

Surface Water Sample Analyzed by ELISA ("dip stick")

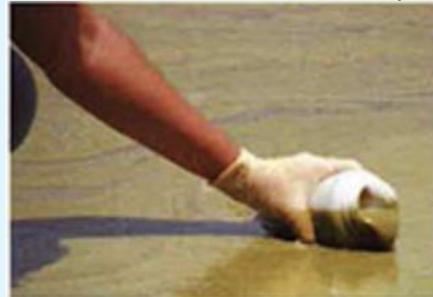
Tube Sampler

Composite Tube Sample from Middle of North End (Obvious Bloom) of the lake 19 August 2019 by Consultant

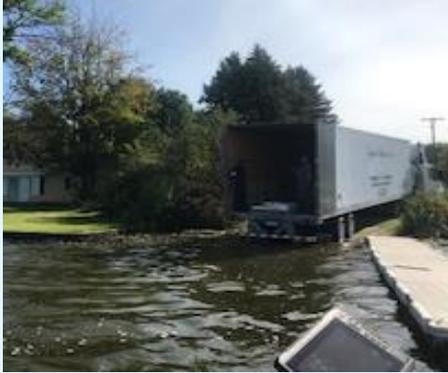
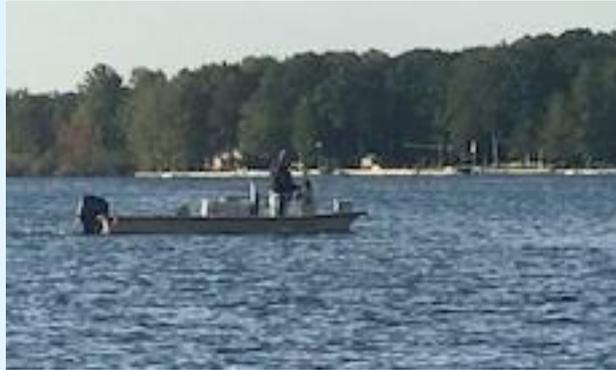
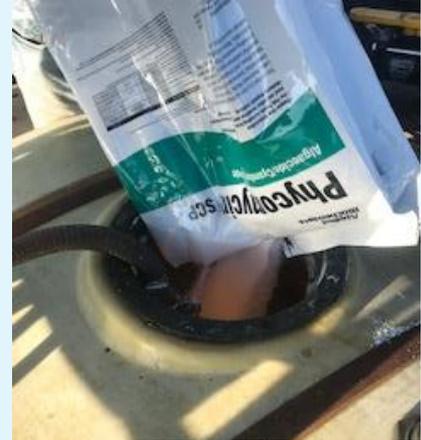
Treatment Design

Mitigation Criteria - Large-Scale, Selective, Depth/Volume Targeted Application of Phycomycin® SCP

Bottom 2 Acre Feet (9' – 11') in Lake Center

Weighted Hose Treatment

Shoreline Treatment of Obvious Blooms by surface spray

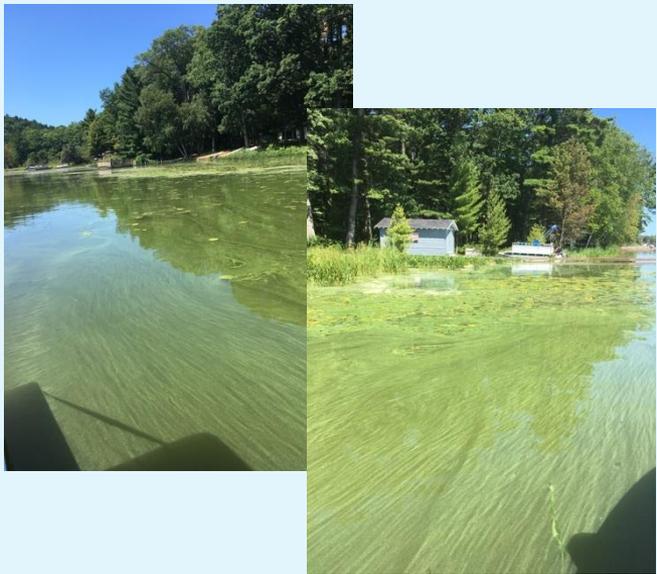
Dramatic decline in Microcystin levels to sub-guidance levels after treatment

<u>Dip Sample Site</u>	<u>20-Aug-19</u>	<u>29-Aug-19</u>	<u>10-Sep-19</u>	<u>19-Sep-19</u>	<u>22-Sep-19</u>	<u>2-Oct-19</u>
Windward Side of Lake (No Obvious Bloom)		12 µ/L	0.94 µ/L			ND µ/L
Southwestern Shore (No Obvious Bloom)	6.60 µ/L	180 µ/L	51 µ/L	<0.50 µ/L	34 µ/L	ND µ/L
North Western Shore 1 (Heavy Bloom)	3,700.00 µ/L	190 µ/L	20 µ/L	0.94 µ/L		ND µ/L
North Western Shore 2 (Heavy Bloom)	610.00 µ/L	240 µ/L	9 µ/L	8.4 µ/L	12 µ/L	1-5 µ/L
	Pre-Treatment		Post-Treatment

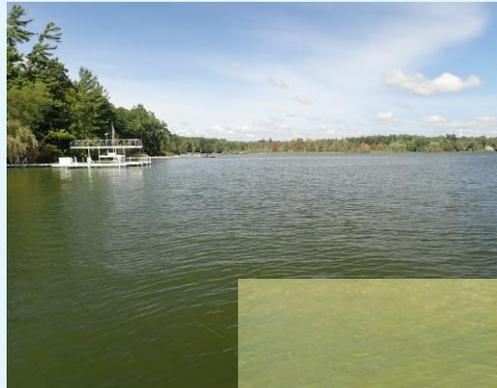
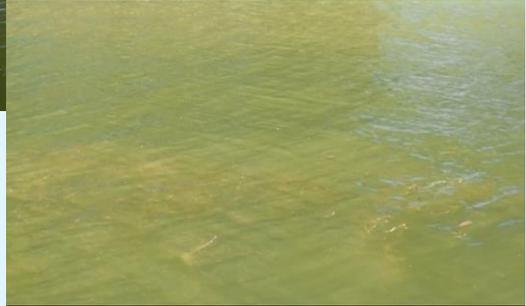
Post-Treatment

Small patches of floating blooms persisted in leeward areas, cyanotoxins greater than guidance levels – too small to warrant treatment?
